EXPLOSIVE FAILURE OF 230 kV AIR BLAST
CIRCUIT BREAKERS AT CHERRYWOOD TS:
THE CAUSE AND THE CURE

R.J. Van Haeren, P.Eng. and M.C. Angemeer
Ontario Hydro
Toronto, CANADA

Canadian Electrical Association
Engineering and Operating Division Meeting

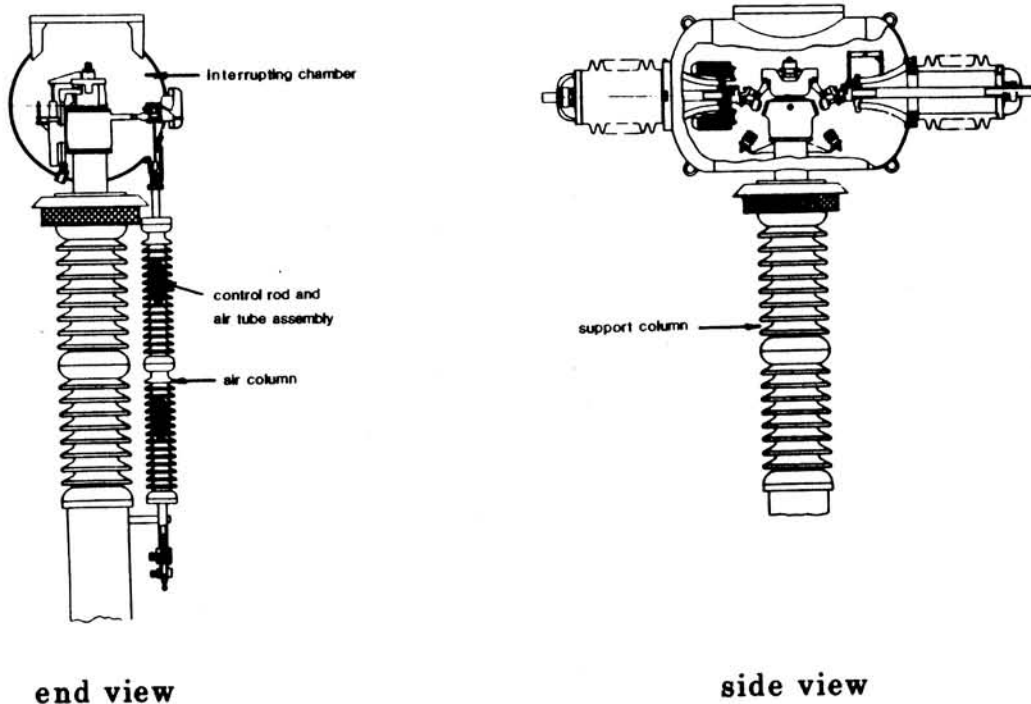
Fig. 1 CGE AT air blast breaker - single pole

In late September, one of the air blast circuit breakers failed explosively. Initial examinations indicated a problem with the air column assembly. This porcelain air column supplies both low pressure insulating air at 515 kPa to the breaker entrance bushings and high pressure control air at 4200 kPa to the interrupting chamber. The high pressure control air is isolated from the insulating air via a fiberglass tube. As well as containing control air, this tube also houses the control rod which actually operates the interrupting mechanism. Under normal operating circumstances both the tube and control rod are required to withstand full line to ground voltage. A single pole of the breaker, showing the air column assembly has been illustrated in Figure 1.

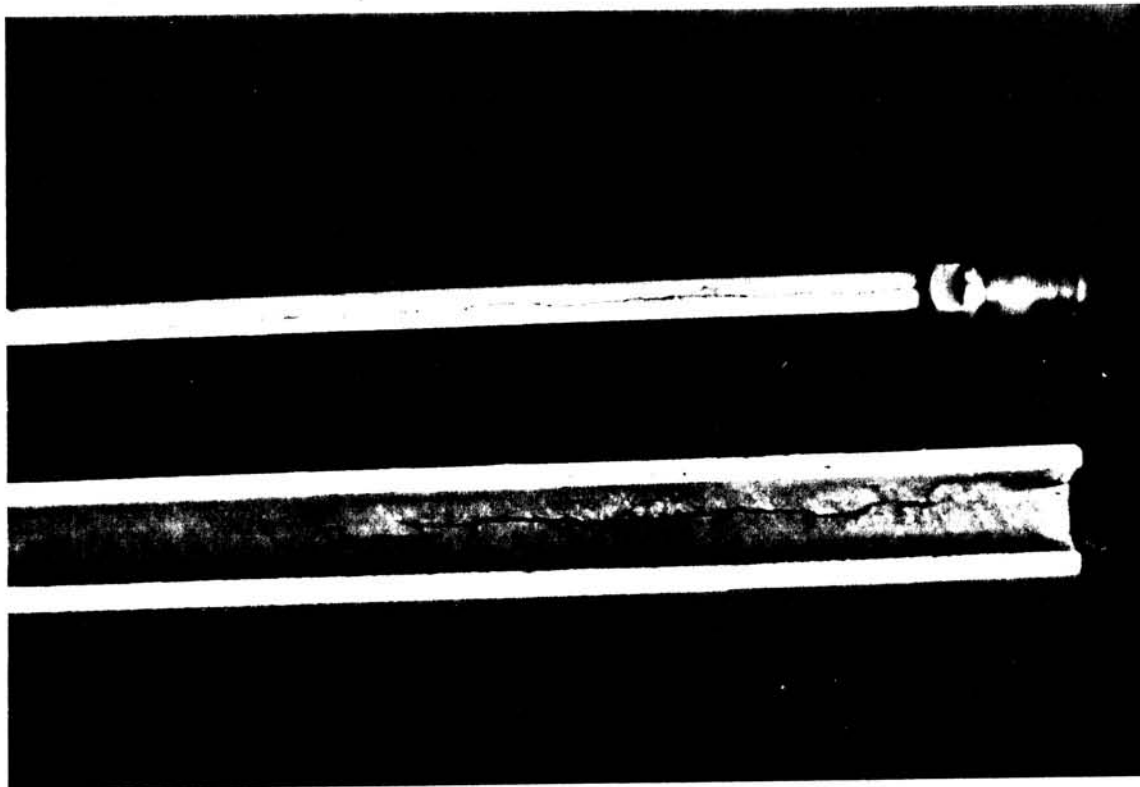
Consequently, moisture slowly progressed through the entire air system and contaminated all components. The most critical of these components were the fiberglass air tube and control rod assemblies. As the ambient temperature fluctuated through a normal daily cycle, the dew points were frequently exceeded and the moisture vapour would begin to condense onto all interior surfaces of the air system. The condensed vapour droplets on both the rods and tubes created distortions in the surface voltage stress and initiated discharges or scintillations. The heat from these discharges, over an extended period of time, gradually eroded the organic insulating material and released free carbon which formed dendritic paths or carbon tracks along the insulating surfaces. Some insulating components removed from service showed signs of severe tracking (see Figure 2). This degradation slowly extended along the surface of the rods and tubes until a point was reached where neither could withstand line to ground voltage.

Fig. 2 Electrical Tracking Along Control Rod and Air Tube

Through a series of extensive equipment outages, lasting a total of 12 weeks, every air blast circuit breaker was inspected internally, and had all air column assemblies removed, dismantled, inspected for corona activity, electrical tracking damage, or the presence of moisture. Both the tubes and rods were cleaned and hipot tested at 425 kV ac prior to being reassembled. Upon inspection, if any sign of deterioration was detected on either the control rod or the air tube, both components were replaced. Table 1 summarizes the extent of rod and tube damage.

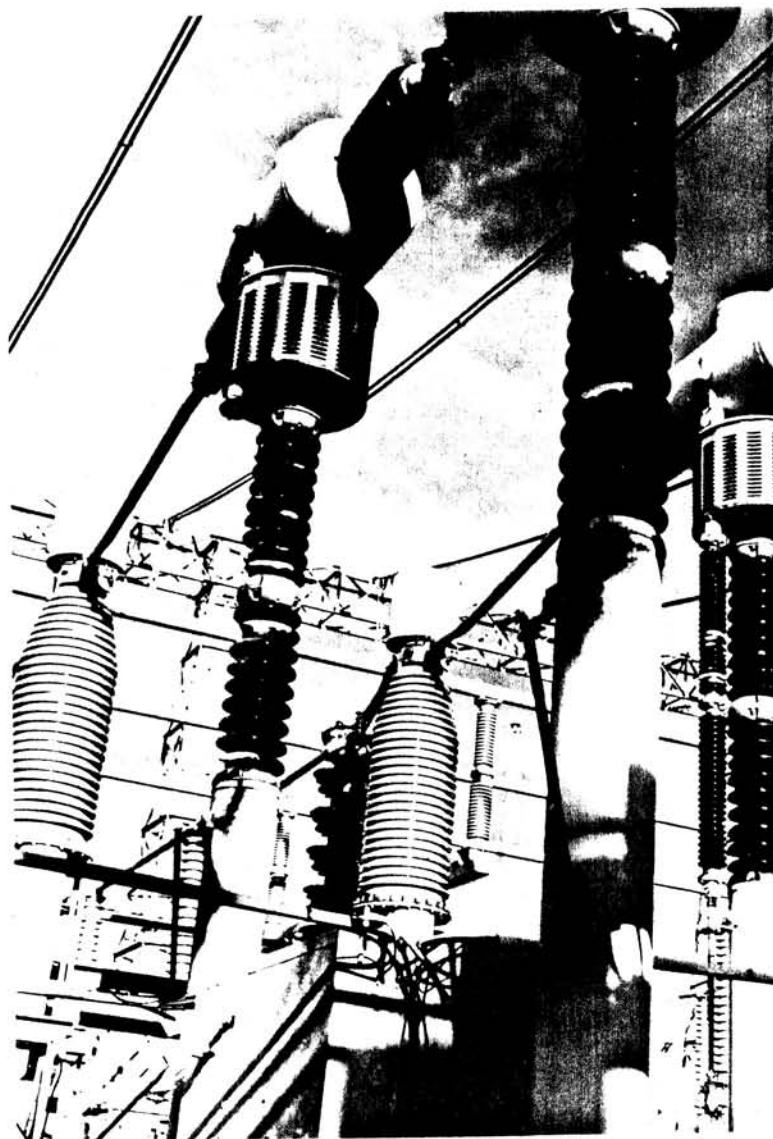
When this tracking phenomena finally led to the flashovers at Cherrywood TS it ruptured the 4200 kPa air tube which in turn shattered the porcelain air column insulators, as illustrated in Figure 3. Initial calculations indicated that the explosive force of the failures propelled the shattered porcelain projectiles through the switchyard at a velocity exceeding 71 m/s. Consequently, special measures had to be put in place to ensure the safety of personnel required to rehabilitate the air system within the switchyard.

Fig. 3 Cherrywood TS Air Blast Breaker Failure

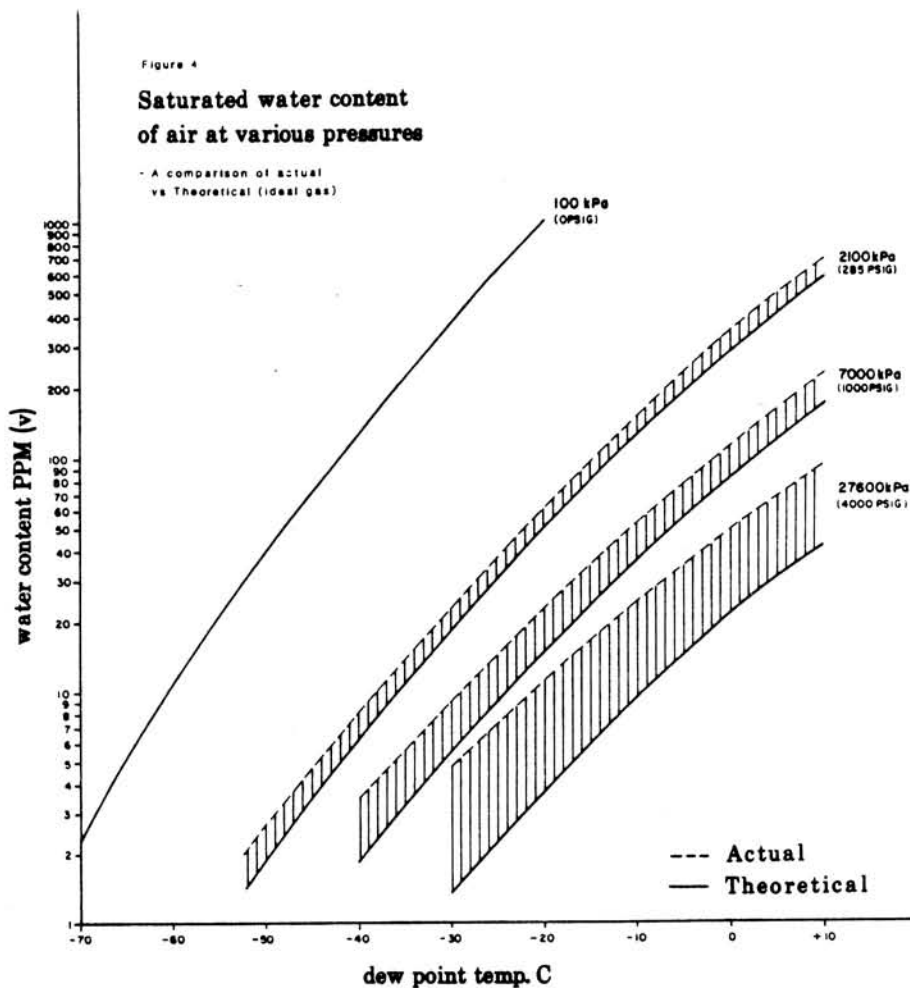
- iv. Ontario Hydro has set a moisture concentration limit of 10 ppm(v) as a standard for the high pressure compressed air systems. Since most of the existing hygrometers give readings only in dew point, conversions are necessary to compare these readings to our standard. Dew point readings at Cherrywood TS were taken at the full line pressure (approx. 7000 kPa) and then converted to either equivalent readings at lower pressures or to moisture concentration in parts per million by volume.

These conversions can be performed through the use of tables, slide rules and nomographs, provided mostly by hygrometer manufacturers, and are based on relationships which assume that the application of ideal gas laws are independent of pressure. Some of these aids claim that they can be used for converting dew points to ppm(v) at pressures of up to 69 MPa. Unfortunately, numerous graphs based on experimental data indicate that at elevated pressures, the relationships assuming ideal gas behaviour can no longer be used [3],[6]. Indications are that above about 1700 kPa the difference between nonideal and ideal conversions becomes significant and at 7000 kPa the difference in moisture concentrations can be as much as 40% at the 10 ppm(v) level. Figure 4 shows comparisons between the two types of conversions at different pressures.

Fig. 4 Saturated Water Content of Air at Various Pressures

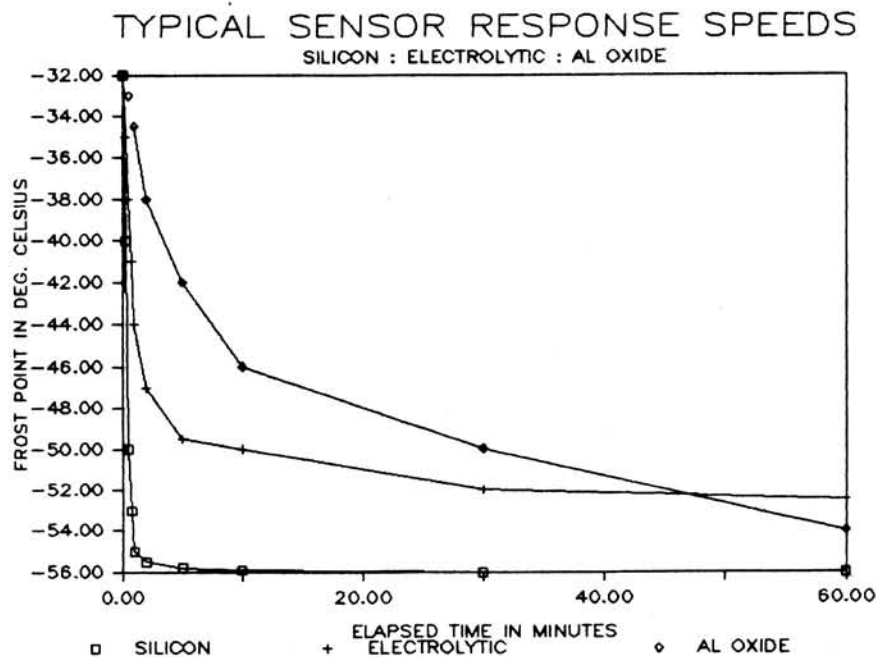
The silicon hygrometer incorporates features and characteristics which best suit our application. Figure 5 shows typical wet-to-dry response times for the various sensor technologies. The fast response speed of the silicon sensor offers definite advantages when numerous moisture readings are required.

Fig. 5 Typical Sensor Response Speeds

Correspondence with utilities, other companies and hygrometer manufacturers, identified competing technologies which are presently on the market. Earlier investigative work performed at Ontario Hydro Research Division as well as other published sources all indicated that hygrometers incorporating silicon technology were superior in accuracy, stability and response time over competing technologies [5],[7]. Silicon hygrometers equipped with temperature controlled sensors were therefore chosen as field replacement units.
